LIFE10NAT/SI/142

Restoration of the Ljubljanica River corridor and improvement of the river's flow regime

Riverine LIFE Platform Meeting

Tartu, 10. 9. 2014

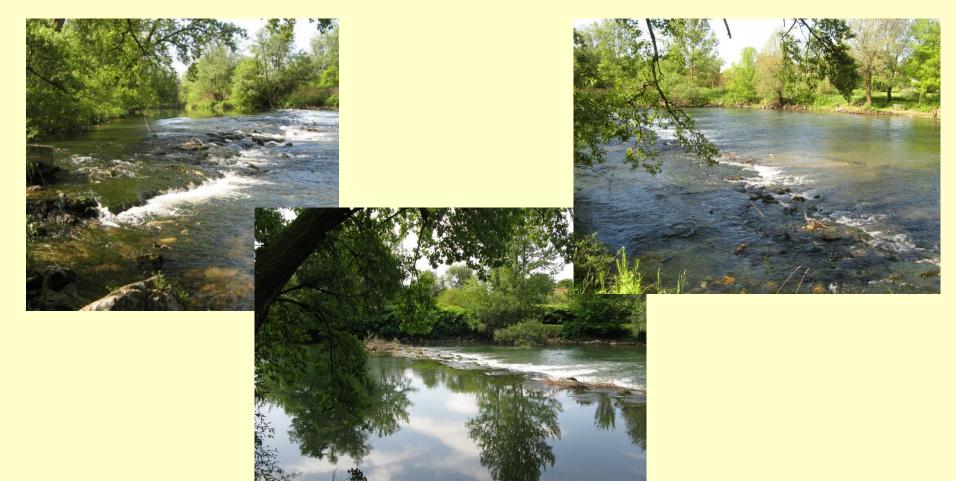
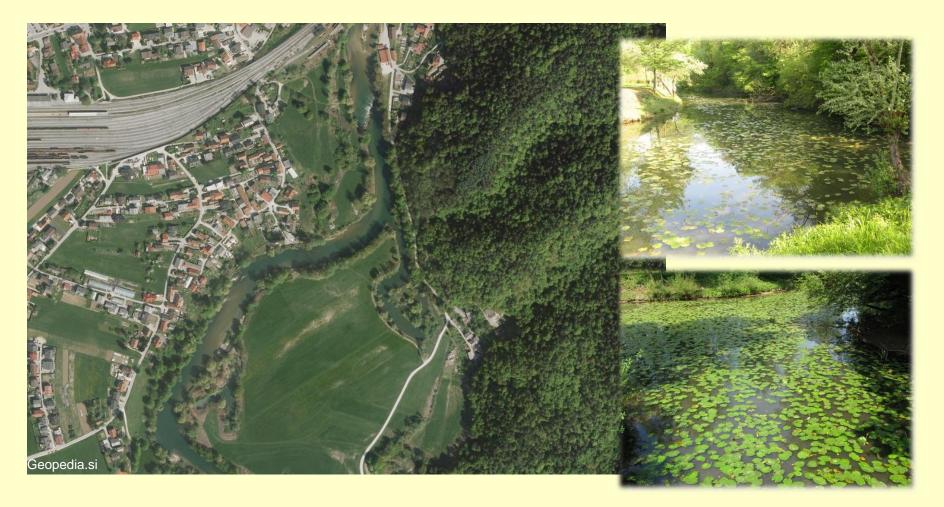
RECONSTRUCTION OF THE SILL

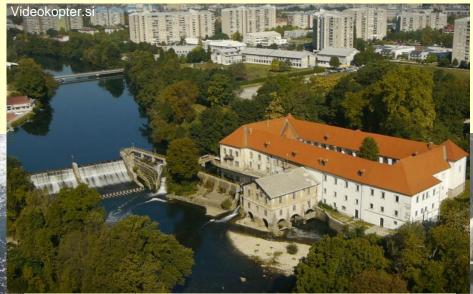
Fish pass No.1 at the beginning of the project

Collapse of the fish pass No.1 in November 2013 due to high water discharge

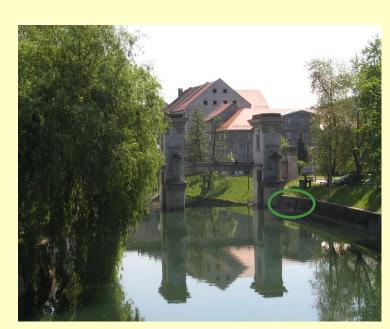
Inflow and outflow of the fish pass No.2

Interior of the fish pass No.2

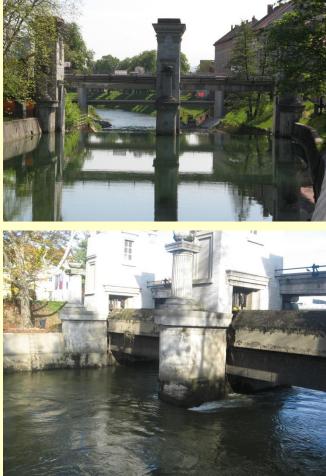
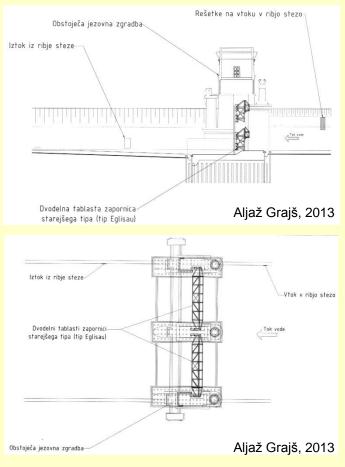
System of two barriers on the Ljubljanica River

Sketches of the initial situation

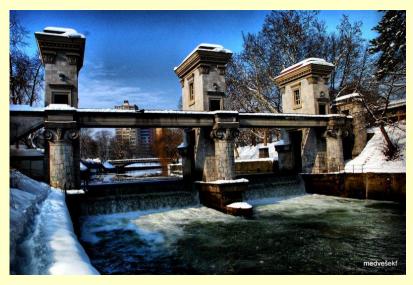
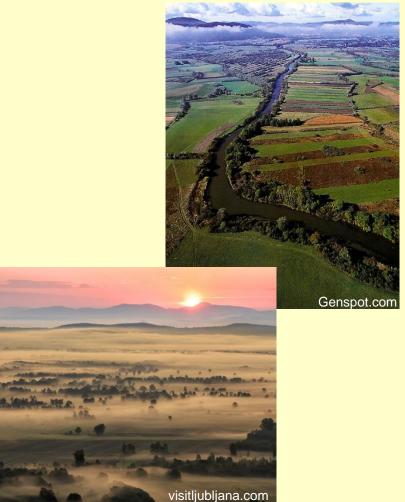
Influence of water level regulation on the upstream wetland Ljubljansko Barje

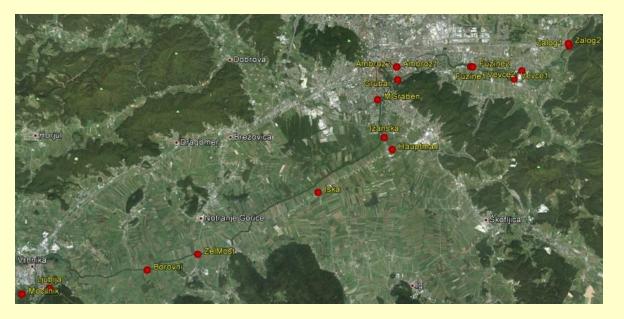
Locations of measurement stations on 3 locations stations with online connection will be installed

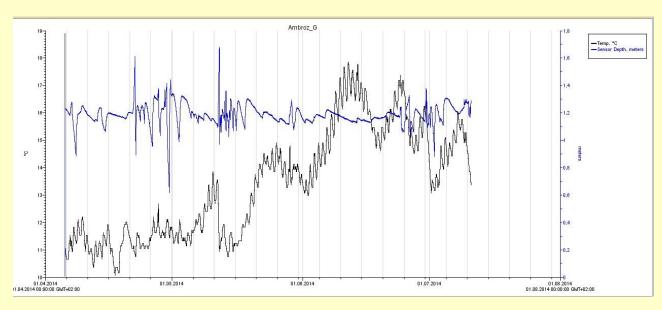
Fluctuations in temperature and water level on measurement station near the barrier

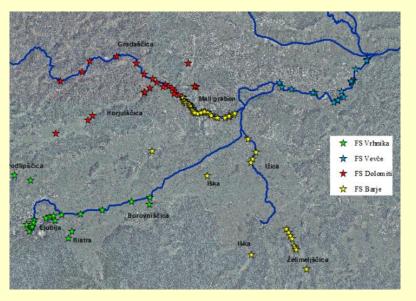
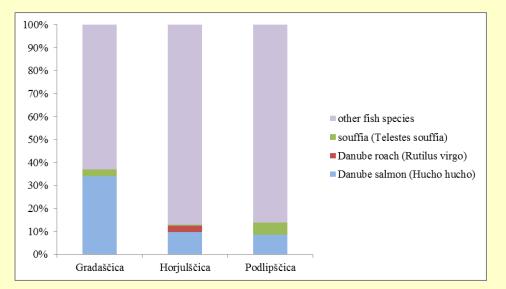
Percentage of Danube Salmon, Danube Roach, Striped Chub and other fish species caught in streams near Ljubljanica River

Result of habitat study: maps with spawning and nursery places of targeted species, their distribution by fishermen information and their potential locations

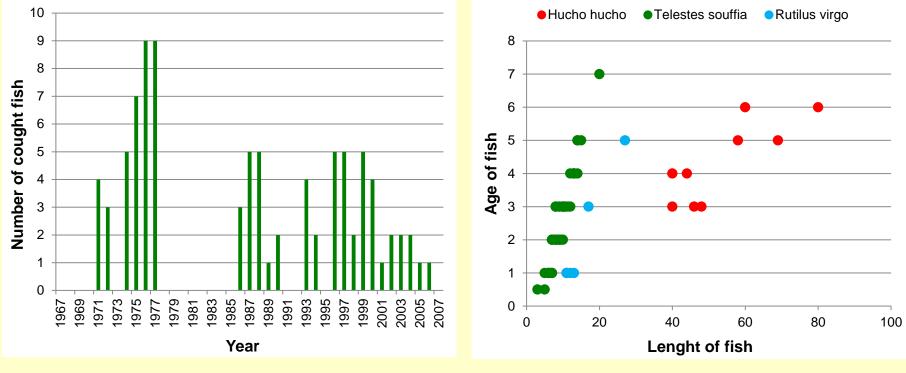
Characteristics of caught fish

Catch of Danube Salmon in Ljubljanica River from the dam at Ambrožev trg to the dam in Vevče paper factory from 1967 to 2007
